FORM A - AREA

Town/City: Beverly

Name of Area: Beckford Street Area

BEVERLY BECKFORD STREET AREA

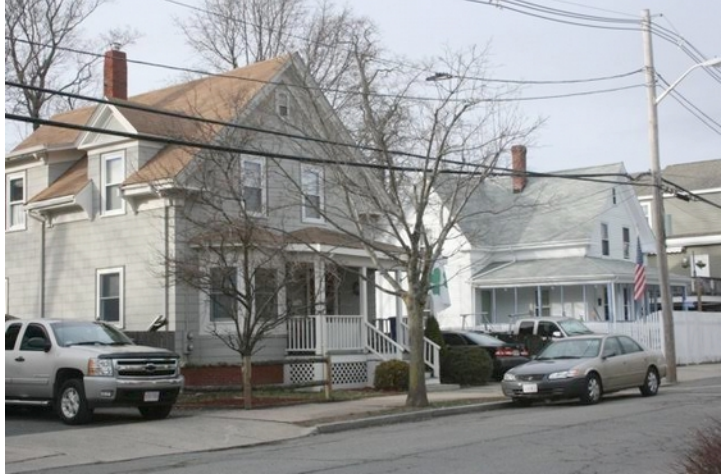
Photo 1: 24 and 26 Beckford St (L to R): View north

Originally L-shaped, 26 Beckford Street (Photos 1 and 2) has a distinctive, wrap around porch with a hip roof and modern posts and balustrades. It is also notable for the prominent dentil band on its horizontal and raking fascia. The façade contains an angled bay and offset entrance on the first floor, two symmetrically placed windows on the second floor, and a very small window centered in the attic. The side wing has one window centered on each floor. A large addition on the rear has a gabled roof, heavy fascia board, and a tall, gabled wall dormer with gable returns.

24 Beckford Street (Photos 1 and 3) features a simple rectangular main block at the front, with a small angled bay window and 3-bay, hip roofed entry porch with eave brackets on the first floor; two windows centered in the half story; and a very small window at the attic level. Walls are trimmed with a high fascia board that has decoratively carved eaves brackets at the corners. The right (northeast) elevation features a long bay window with a hip roof at the first floor and two dormers at the half story, one with a pedimented gable roof and the other with a hip roof. The left (southwest) elevation has a pedimented gabled dormer towards the street and a long, shed-roofed wall dormer at the rear. A one-story extension with a gable roof is set on the southern end of the rear elevation, while a full two-story addition with a second story entrance projects from its northern end.

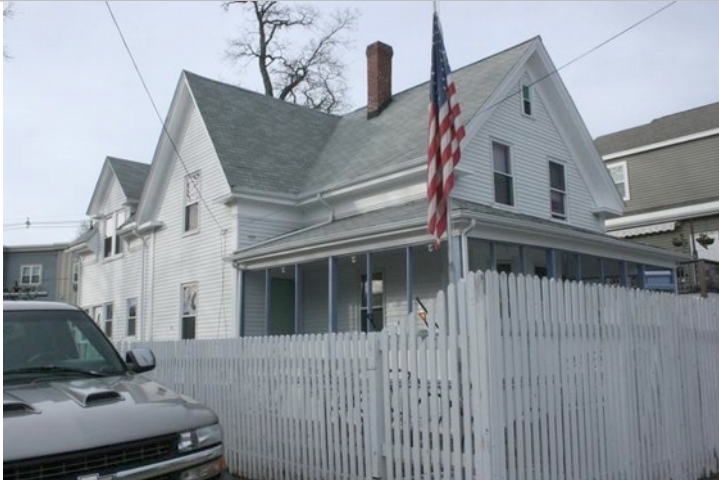
Photo 2: 26 Beckford Street: Southwest and southeast (façade) elevations

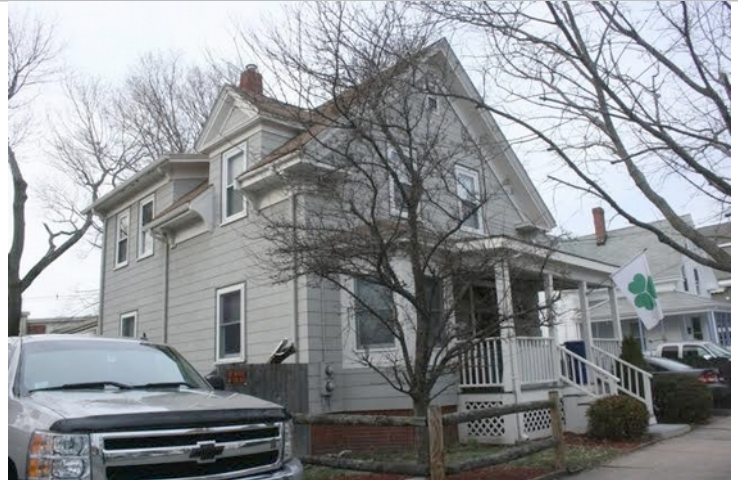
Photo 3: 24 Beckford Street: Southwest and southeast (façade) elevations

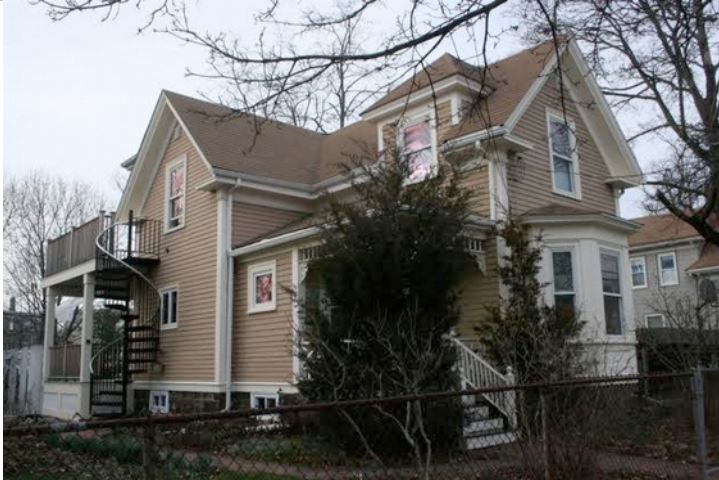
Photo 4: 22 Beckford Street: Southwest and southeast (façade) elevations

22 Beckford Street (Photo 4) has a cruciform shape, with side wings set well back from the front gabled façade. The main entrance porch, occupying the corner to the south of the front block, has a hip roof, small enclosed vestibule at the inner end with a street-facing door, square posts supporting a spindle railing at the top, and delicately sawn brackets at the corners. Its wood railing and newel posts appear original or early. The symmetrical façade of the front block has an angled bay window at the first story and one window in the half story above. The left (southwest) side of the front block has a hip roofed wall dormer. The gable ends of the south and north wings of the house have one window bay centered on each floor; most of their fenestration has been altered. A two-story rear porch at the west corner of the building is accessed by a spiral staircase. The only house in the district on which wood clapboards are visible, 22 Beckford Street is trimmed with molded sill boards, corner boards, and fascia boards.

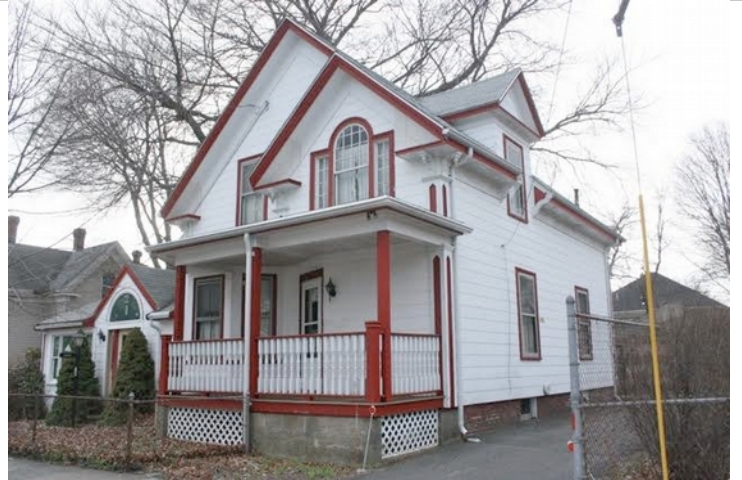
Photo 5: 20 Beckford Street: Northeast and southeast (façade) elevations

20 Beckford Street (Photo 5) exhibits the area's most elaborate embellishment, with paneled corner pilasters, carved eave brackets on its rectangular main block. An offset, slightly projecting pavilion rises full height, with an off-center doorway at the first floor and a multi-pane Palladian window in its half story. Other windows typically contain 2/2 double hung sash. A hip roofed entry porch shelters the first floor of the pavilion and connects to an offset angled bay window. The northeast elevation features two asymmetrical windows at the first floor and a pedimented gabled wall dormer at the half story. The southwest elevation has two pedimented gabled wall dormers at the half story. A large, low addition extends to the southwest on the first floor, flush with the main block, with a side gable roof. The addition's façade has a modern picture window unit and a secondary entrance featuring a modern doorway with sidelights, large semi-circular transom, and cross gable.

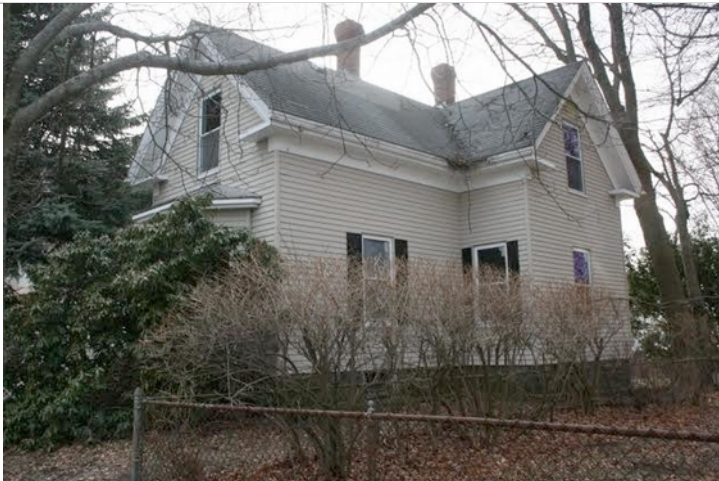
Photo 6: 18 Beckford Street: Northeast and southeast (façade) elevations

18 Beckford Street (Photo 6) has a T-shaped plan with an entrance porch in the corner to the south of the front block. The entrance porch has a shed roof, a small entrance vestibule with a street-facing door, square posts with curved sawn brackets, and a modern metal railing. The symmetrical façade of the front block has an angled bay window at the ground floor and a single window above. Each of the other elevations has one window bay centered on it; there are no dormers. A room-sized addition at the rear of the block rises one story to a gabled roof.

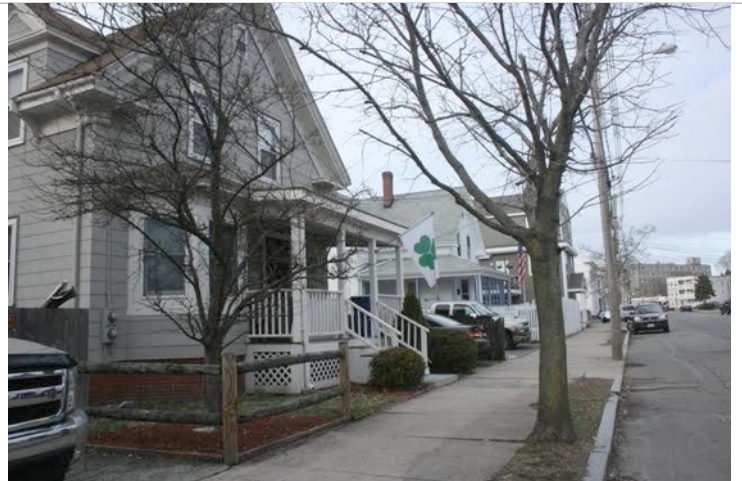
Photo 7: 24 and 26 Beckford Street (L to R): View northeast towards Cabot Street
